A NEW GENERATION
OF SURFACE TREATMENT

MIPOLAM

evercare™ on MIPOLAM

an exclusive Gerflor patented coating with resistance and performance obtained by UV laser cross-linking

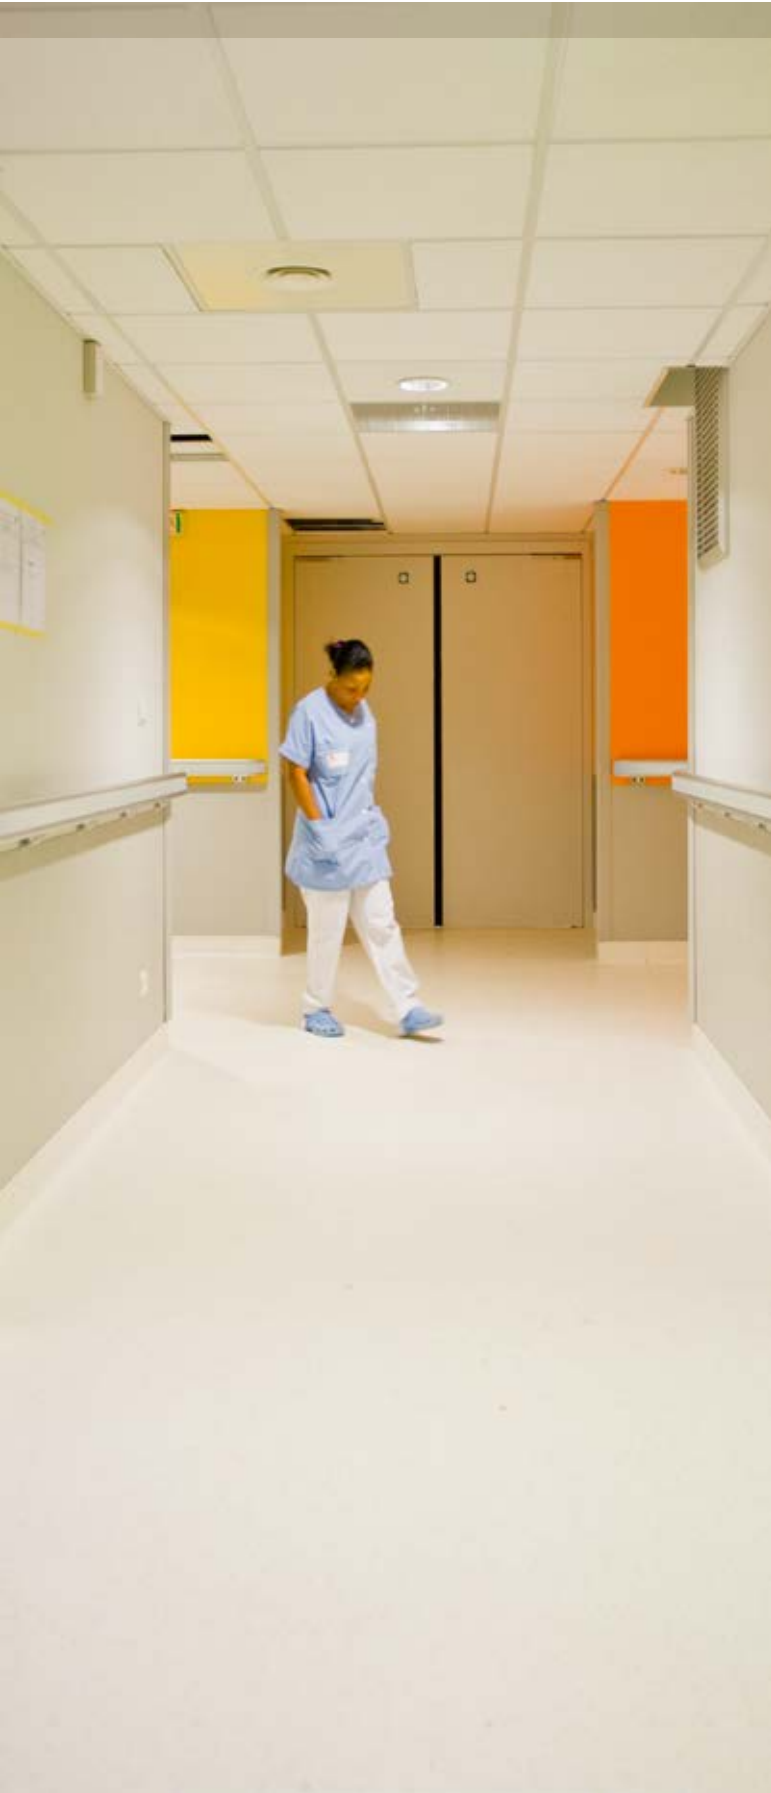
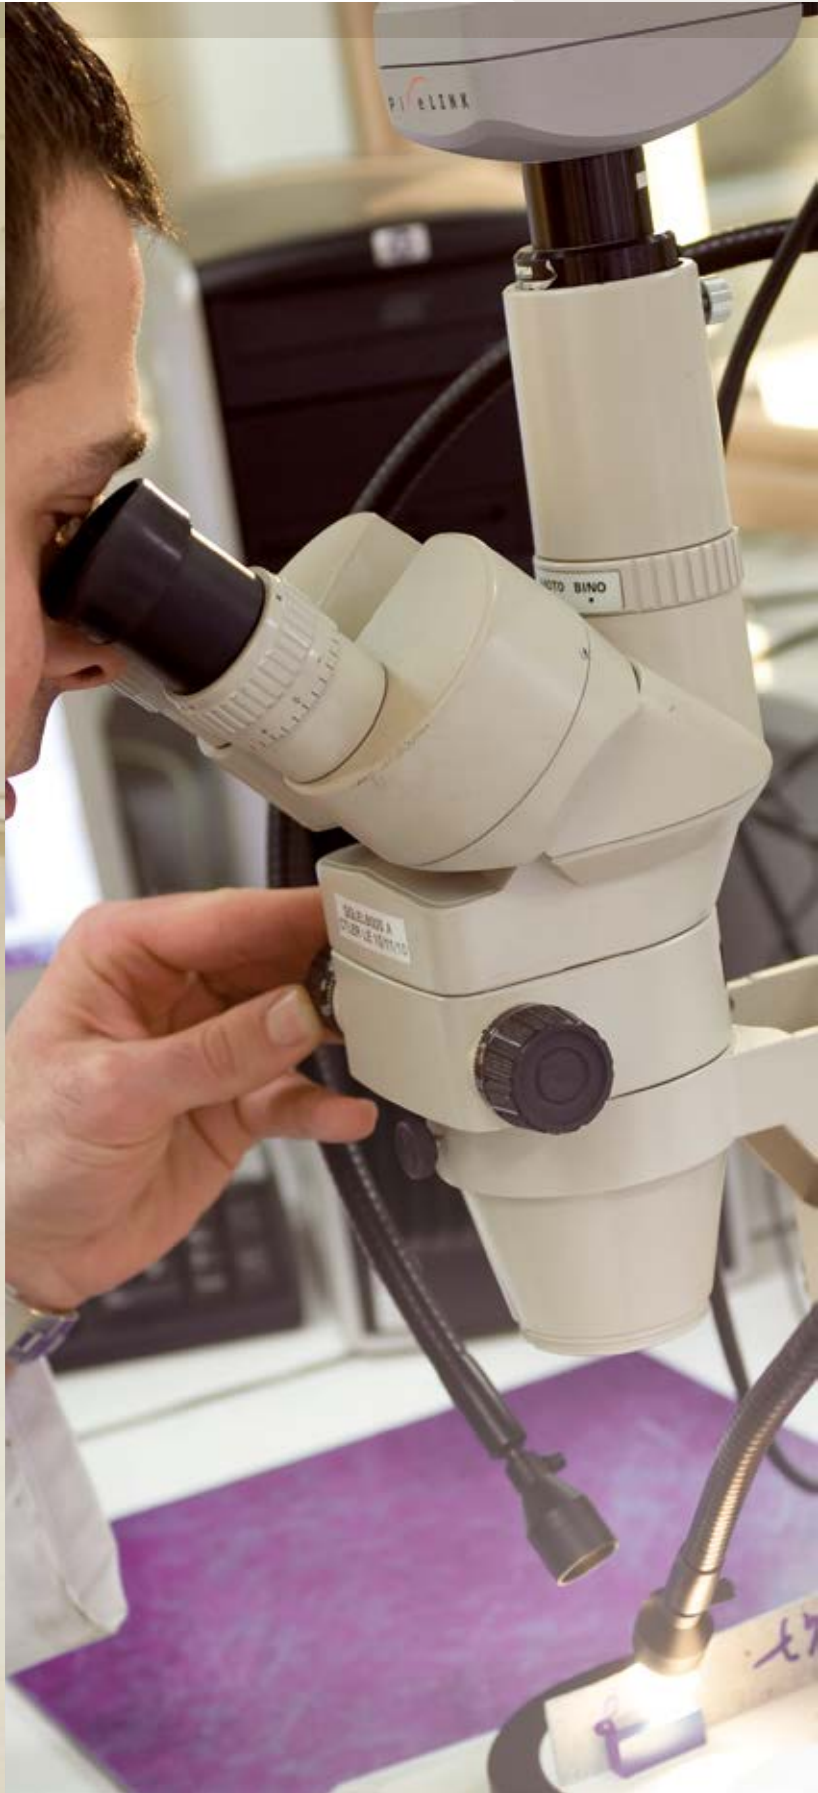
STAINING TESTS

<p>Highly Durable: Exclusive surface treatment applied by UV laser cross-linking provides superior durability and an even surface thickness, creating an impenetrable barrier against stains and chemicals found in healthcare.</p> <p>Life expectancy of over 20 years.</p>	<p>evercare™ BY GERFLOR GERFLOR: EVEN THICKNESS</p>	<p>OTHER TREATED FLOOR COVERING COMPETITOR: MISSING TREATMENT AND UNEVEN THICKNESS</p>
<p>100% non-porous surface: The surface treatment creates a 100% non-porous barrier to all liquids and chemicals, keeping all stains floating on the surface.</p> <p>Simple and easy stain removal.</p>

RESULTS AFTER CLEANING

EVERCARE™ TECHNOLOGY	OTHER HOMOGENEOUS SHEET	RUBBER	LINOLEUM	VCT
<p>Using a neutral detergent</p>	<p>After 5 minutes</p>					
	<p>After 60 minutes</p>					
<p>Stain 1: BETADINE® IODINE</p>	<p>After 5 minutes</p>					
	<p>After 60 minutes</p>					
<p>Stain 3: PERMANENT MARKER*</p>	<p>After 5 minutes</p>					
	<p>After 60 minutes</p>

* ONLY with the Evercare™ Technology can the marker stain be erased with a common eraser
